DTC	B1263 / 63	Rear Junction Block ECU communication stop
------------	-------------------	---

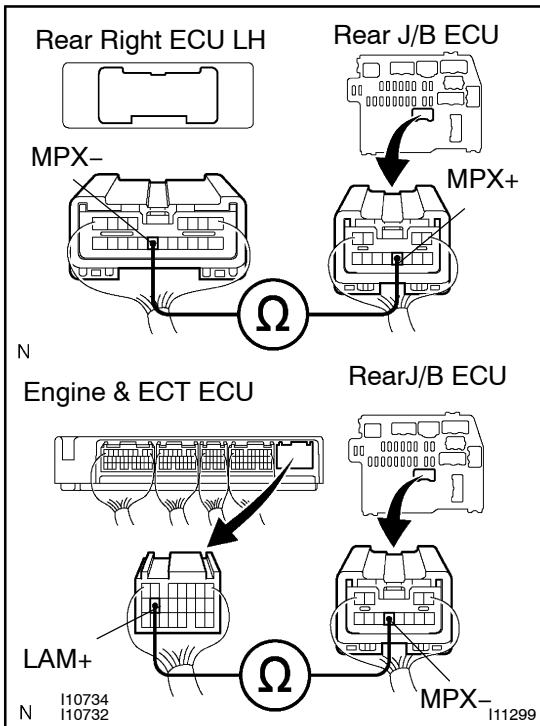
2 Check wireharness

Disconnect connector "R31" of rear left door ECU, "E5" of Engine and ECT ECU and "R27" of rear J/B ECU.

- Check continuity between terminals MPX- of rear light ECU LH and MPX+ of rear J/B ECU.
- Check continuity between terminals MPX- of rear J/B ECU and LAM+ of Engine and ECT ECU.

There is a continuity in wireharness of both (a) and (b), or either (a) or (b).

If there is OPEN in wireharness of either (a) or (b), please repair it.

Repair or replace wireharness.

Replace rear J/B ECU.
