DTC	P1640/89	Communication Malfunction No.1
-----	----------	--------------------------------

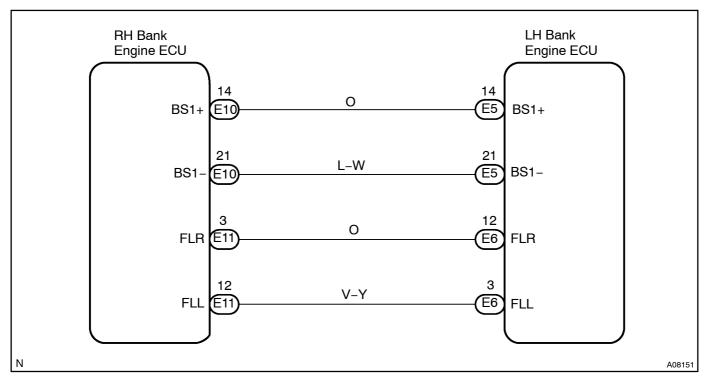
WIRING DIAGRAM

LH bank engine ECU and RH bank engine ECU always communicate the data with vehicle general control and diagnosis function each other via communication line.

DTC No.	Detection Item	Trouble Area
P1640/89	When run-pulse signal of ECU communication is fixed ON or	Wire harness
	OFF for 88 msec. at opposite ECU.	• Engine ECU

1 Check for open and short in harness and connector between each terminals BS1+ and BS1- of LH and RH bank engine ECU (See page IN-20).

NG Repair or replace harness or connector.

Check and replace opposite bank engine ECU when that ECU detects P1640/89.
