FRONT LOWER BALL JOINT ON-VEHICLE INSPECTION

SAQJI-02

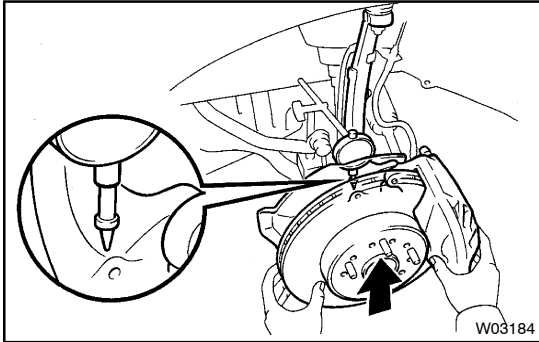
- (a) Remove the front wheel and check the lower ball joint boot. If the boot is damaged, replace the lower ball joint.
- (b) Place the magnetic base on the strut rod and position the tip of the dial indicator to the knuckle arm as shown in the illustration.
- (c) Check the excessive play of the lower ball joint when you push the axle up with your hands.

Maximum play: 0.3 mm (0.012 in.)

If it is not within the specified value, replace the lower ball joint.
