## REAR COOLING UNIT ON-VEHICLE INSPECTION

AC259-01

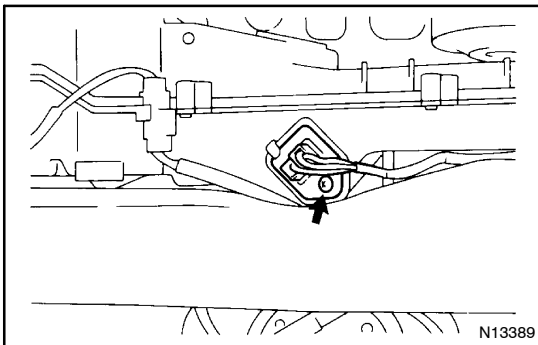
- (a) Remove the blower resistor.
  - (1) Disconnect the connector.
  - (2) Remove the screw and blower resistor.
- (b) Using a gas leak detector, check for leakage.

If there is leakage, check the tightening torque at the joints or check the evaporator.
