DTC	P1640/89	Communication Malfunction No.1
------------	-----------------	---------------------------------------

CIRCUIT DESCRIPTION

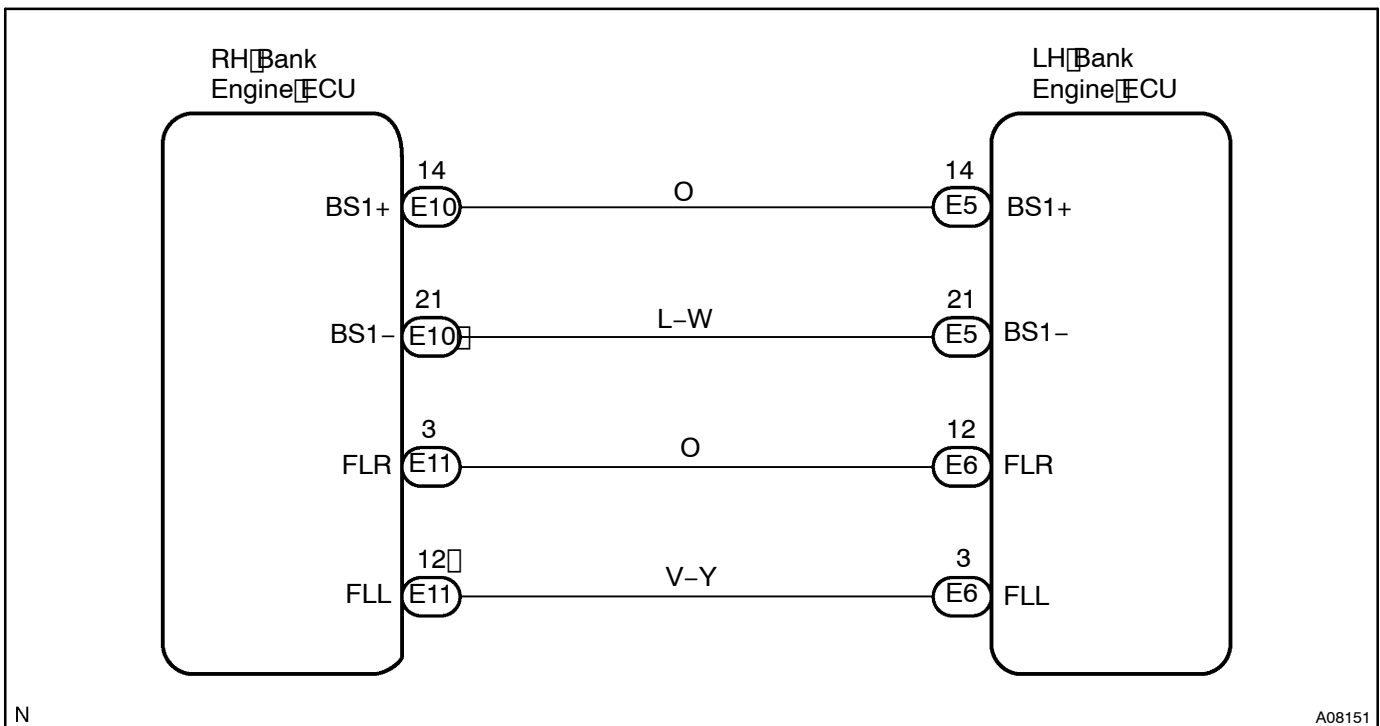
WIRING DIAGRAM

LH bank engine ECU and RH bank engine ECU always communicate the data for vehicle general control and diagnosis function each other via communication line.

1	Check for open and short in harness and connector between each terminals BS1+ and BS1- of LH and RH bank engine ECU (See page IN-20).
---	---
