DTC	B0113/42	Short in Front Side Squib (RH) Circuit (to B+)
-----	----------	--

# **CIRCUIT DESCRIPTION**

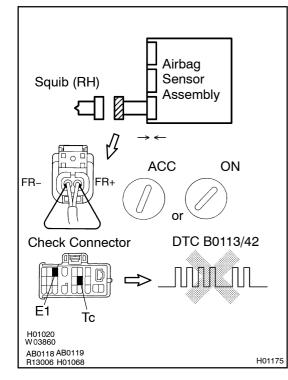
#### PREPARATION:

- (a) Connect the connector to the airbag sensor assembly.
- (b) Using a service wire, connect FR+ and FR- of the connector (on the front side airbag assembly side) between the front side airbag assembly (RH) and the airbag sensor assembly.
- (c) Connect negative (-) terminal cable to the battery, and wait at least for 2 seconds.
