UPPER BACK PANEL (ASSY)

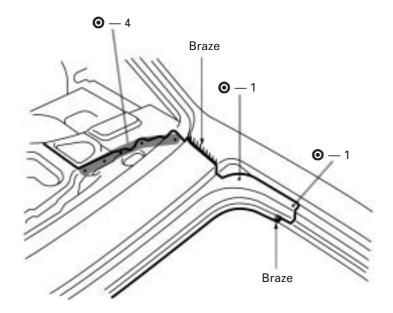
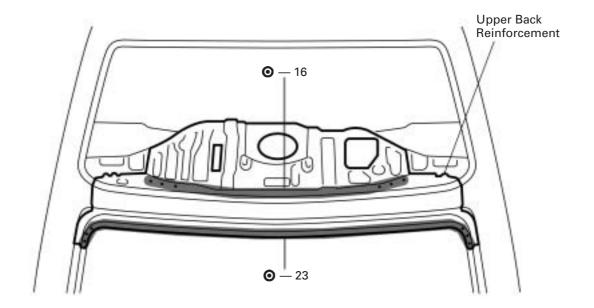
REMOVAL

1. Leave the parts other than the upper back reinforcement on the vehicle side.

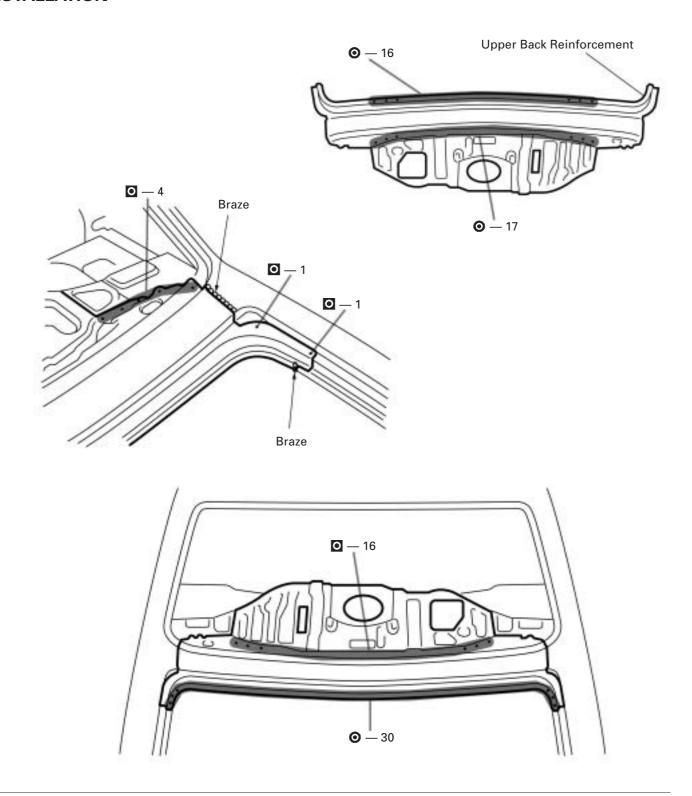
INSTALLATION

- 1. Remove only upper back reinforcement from the new parts.
- 2. Temporarily install the new part and check the fit of the luggage compartment door.
