DIAGNOSTICS - SUPPLEMENTAL RESTRAINT SYSTE	M
--	---

B0105/53

Short in P Squib Circuit

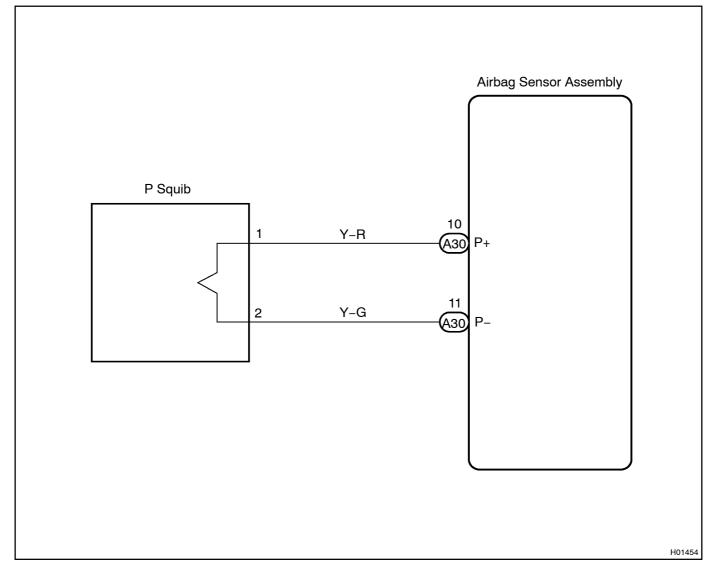
WIRING DIAGRAM

The P squib circuit consists of the airbag sensor assembly and front passenger airbag assembly. It causes the SRS to deploy when the SRS deployment conditions are satisfied.

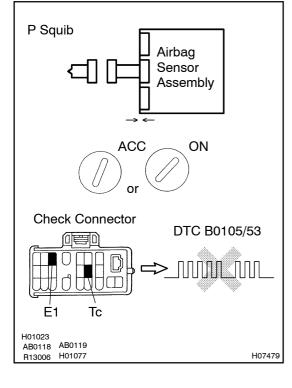
For the connector (on the front passenger airbag assembly side) between the front passenger airbag assembly and the airbag sensor assembly, measure the resistance between P+ and P-.

Resistance: 1 M Ω or Higher

Repair or replace harness or connector between front passenger airbag assembly and airbag sensor assembly.

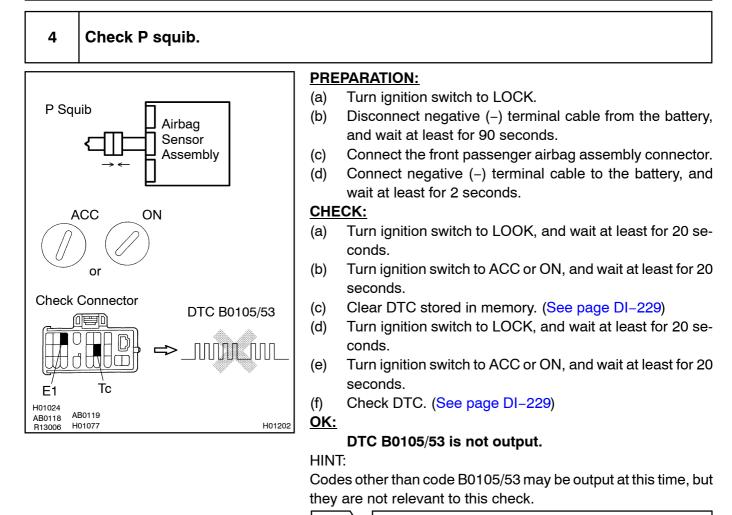
- (a) Connect the connector to the airbag sensor assembly.
- (b) Connect negative (-) terminal cable to the battery, and wait at least for 2 seconds.

- (a) Turn ignition switch to ACC or ON and wait at least for 20 seconds.
- (b) Clear DTC stored in memory. (See page DI-229)
- (c) Turn ignition switch to LOCK, and wait at least for 20 seconds.
- (d) Turn ignition switch to ACC or ON, and wait at least for 20 seconds.
- (e) Check DTC. (See page DI-229)

DTC B0105/53 is not output.

Replace airbag sensor assembly.
