DI16W-21

DTC	B0135/73	Short in P/T Squib (LH) Circuit
-----	----------	---------------------------------

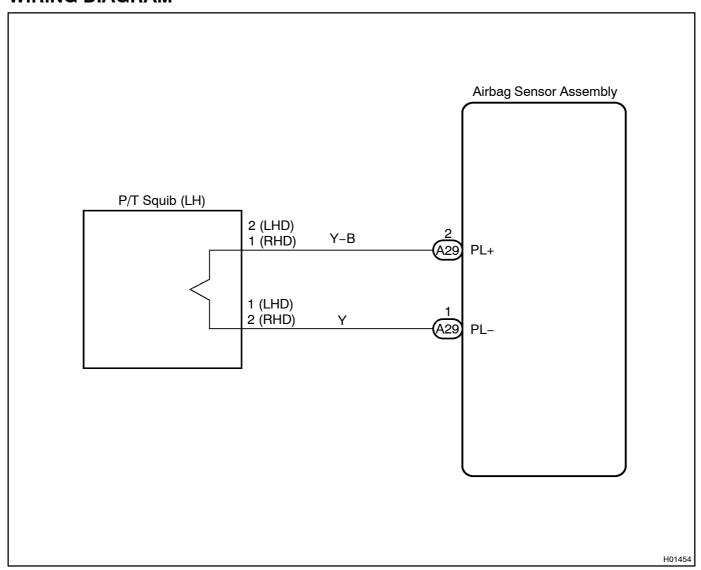
WIRING DIAGRAM

The P/T squib (LH) circuit consists of the airbag sensor assembly and seat belt pretensioner (LH). It causes the SRS to deploy when the SRS deployment conditions are satisfied. For details of the function of each component, see OPERATION on page RS-3. DTC B0135/73 is recorded when a short is detected in the P/T squib (LH) circuit.

DTC No.	DTC Detecting Condition	Trouble Area
B0135/73	Short circuit between PL+ wire harness and PL- wire harness of squib P/T squib (LH) malfunction Airbag sensor assembly malfunction	Seat belt pretensioner (LH) Airbag sensor assembly Wire harness

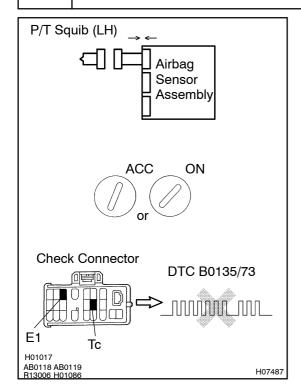
3 Check airbag sensor assembly.

PREPARATION:

- (a) Connect the connector to the airbag sensor assembly.
- (b) Connect negative (-) terminal cable to the battery, and wait at least for 2 seconds.

- (a) Turn ignition switch to ACC or ON and wait at least for 20 seconds.
- (b) Clear DTC stored in memory. (See page DI-229)
- (c) Turn ignition switch to LOCK, and wait at least for 20 seconds.
- (d) Turn ignition switch to ACC or ON, and wait at least for 20 seconds.
- (e) Check DTC. (See page DI-229)

DTC B0135/73 is not output.

Replace airbag sensor assembly.

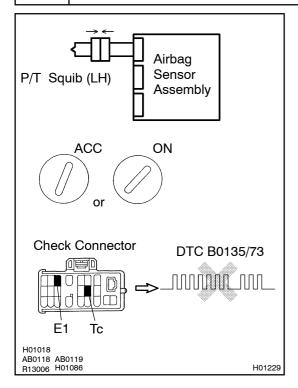
4 Check P/T squib (LH).

PREPARATION:

- (a) Turn ignition switch to LOCK.
- (b) Disconnect negative (–) terminal cable from the battery, and wait at least for 90 seconds.
- (c) Connect the seat belt pretensioner (LH) connector.
- (d) Connect negative (-) terminal cable to the battery, and wait at least for 2 seconds.

- (a) Turn ignition switch to LOOK, and wait at least for 20 second.
- (b) Turn ignition switch to ACC or ON, and wait at least for 20 seconds.
- (c) Clear DTC stored in memory. (See page DI-229)
- (d) Turn ignition switch to LOCK, and wait at least for 20 seconds.
- (e) Turn ignition switch to ACC or ON, and wait at least for 20 seconds.
- (f) Check DTC. (See page DI-229)

DTC B0135/73 is not output.

NG Replace seat belt pretensioner (LH).
