DI1BH-12

DTC	B0132/61	Short in P/T Squib (RH) Circuit (to Ground)	
-----	----------	---	--

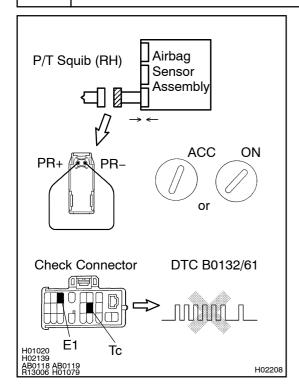
# 3 Check airbag sensor assembly.

### PREPARATION:

- (a) Connect the connector to the airbag sensor assembly.
- (b) Using a service wire, connect PR+ and PR- of the connector (on the seat belt pretensioner side) between the seat belt pretensioner (RH) and the airbag sensor assembly.
- (c) Connect negative (–) terminal cable to the battery, and wait at least for 2 seconds.

### **CHECK:**

- (a) Turn ignition switch to ACC or ON and wait at least for 20 seconds.
- (b) Clear DTC stored in memory. (See[step[spn]page[DI-229)
- (c) Turn ignition switch to LOCK, and wait at least for 20 seconds
- (d) Turn ignition switch to ACC or ON, and wait at least for 20 seconds.
- (e) Check DTC. See page DI-229)

# DTC B0132/61 is not output.

Replace airbag sensor assembly.

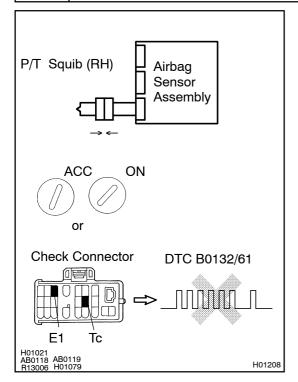
# 4 Check P/T squib (RH).

### PREPARATION:

- (a) Turn ignition switch to LOCK.
- (b) Disconnect negative (–) terminal cable from the battery, and wait at least for 90 seconds.
- (c) Connect the seat belt pretensioner (RH) connector.
- (d) Connect negative (-) terminal cable to the battery, and wait at least for 2 seconds.

#### **CHECK:**

- (a) Turn ignition switch to ACC or ON, and wait at least for 20 seconds.
- (b) Clear DTC stored in memory. (See\step\p\n\page\DI-229)
- (c) Turn ignition switch to LOCK, and wait at least for 20 seconds.
- (d) Turn ignition switch to ACC or ON, and wait at least for 20 seconds.
- (e) Check DTC. See page DI-229)

DTC B0132/61 is not output.

Replace seat belt pretensioner (RH).
